SCRUTINEERS' BULLETIN

June 2019 (163)

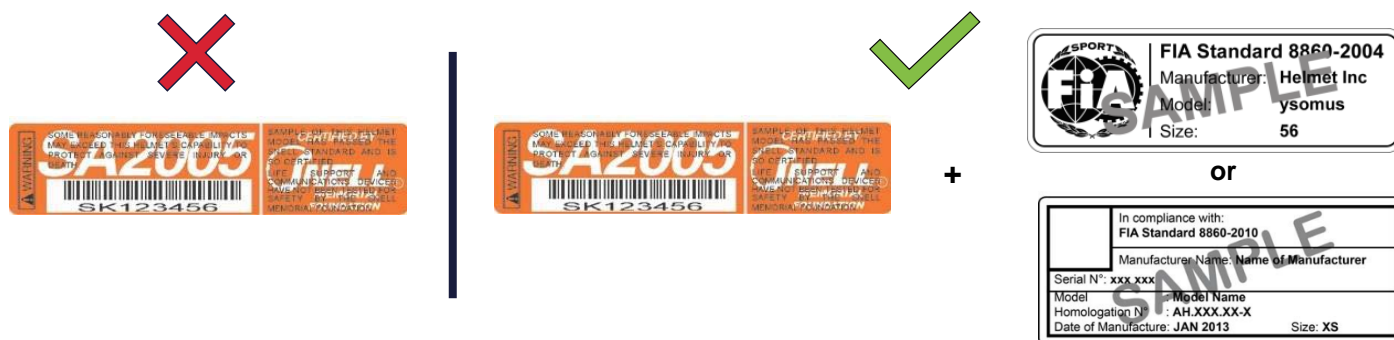
A reminder that the Snell SA2005 helmet was withdrawn from the list of accepted standards at the end of 2018; however, this does not mean that every helmet manufactured to this standard cannot be used in Motorsport UK events. Some helmets have dual standards, holding a Snell and FIA standard with both standards appearing on the helmet – if the SA2005 standard appears along with a valid FIA Standard listed in (K)10.3.1, then this helmet is valid for use in Motorsport UK events. The later FIA standard overrides the expired Snell standard, for example a helmet marked with the Snell SA2005 and FIA 8869-2004 will still be acceptable up until the end of 2020.

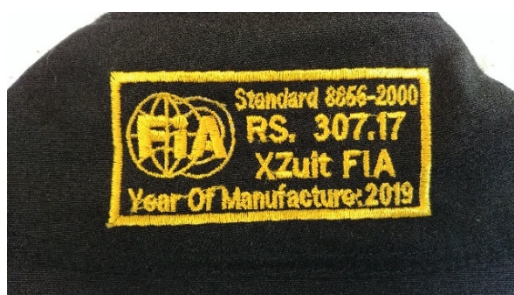
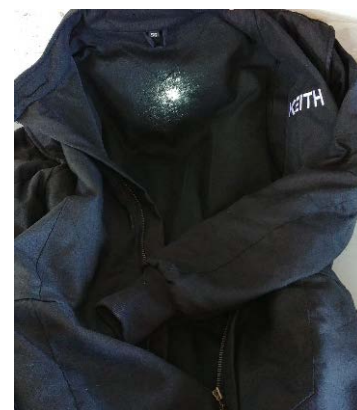
These pictures were sent in by a keen-eyed scrutineer who noticed the material used and the general build of the suit was to a poor quality.

The stitching on the collar of the suit that holds the FIA standard information and the year of manufacture in had thread linking each letter together and a general

poor standard of embroidery, the FIA logo is an incorrect design and to a lower quality than normally seen. The details on the collar states it was manufactured in 2019, therefore also missing from the suit was the FIA hologram adjacent to the zip, which is part of the latest labeling system that has been in place since 01.01.2013.

What was even more apparent was that light could be seen shining through the material on the back of the suit perhaps suggesting the incorrect material had been used in the manufacturing of the suit – additionally the cuffs of the suit appeared to be made from a nylon type material. The suit was impounded for the duration of the event and fortunately the competitor had a spare pair of overalls which were to the correct standard and in suitable condition.

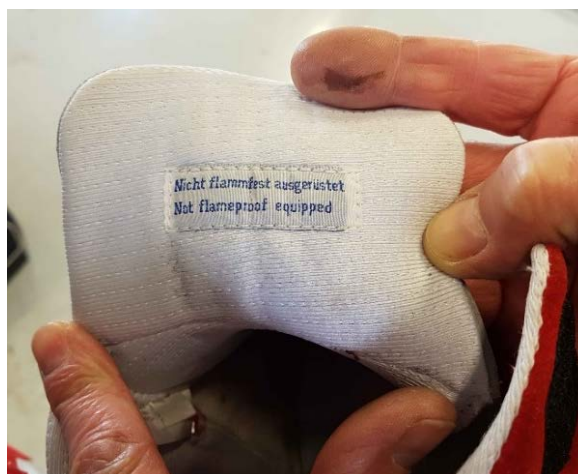
A competitor presented his boots at a recent event and the scrutineer noticed this label in the tongue of the shoe. The label that states, 'Not flameproof equipped'. Where protective shoes are required by specific regulations, the garments must be tested to ISO 6940 or a relevant FIA standard, with all fastenings and laces to be of a non-fusible material along with all threads to be flame resistant. The boots in question were impounded for the duration of the event and the competitor was able to purchase a new pair which conformed to the correct standards for flame resistant boots.

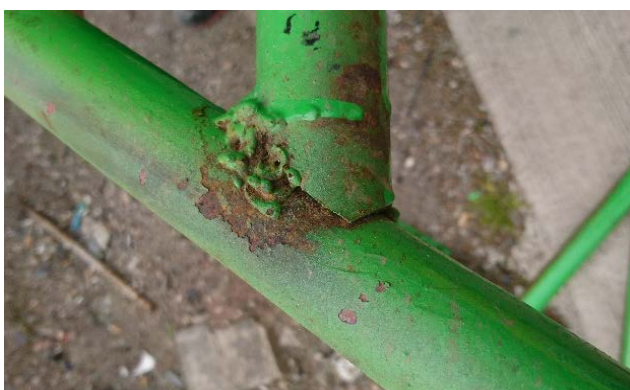
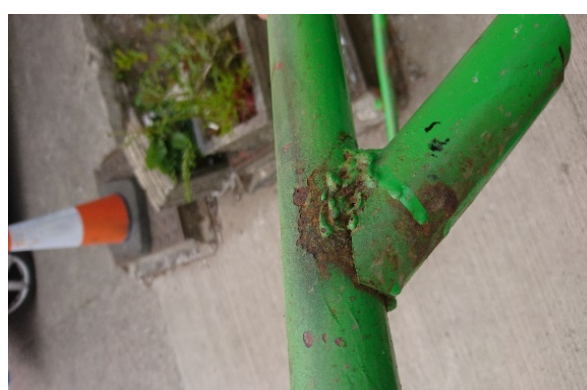
The following pictures were sent in by a scrutineer demonstrating poor workmanship on a ROPS. Not only is the welding of a poor quality, but the weld barely makes it half way around the join between the two bars and is of poor penetration – it is quite clear that if this ROPS were be in an accident it would not offer much protection. Guidance on welding can be found in section K1.3.8.

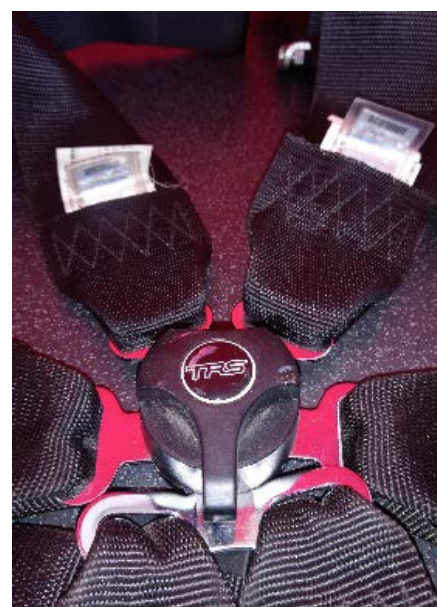
The harnesses in this photograph were sent in by a Scrutineer from a recent event at Snetterton. They were found with two labels/holograms, one on each shoulder strap, when only one should be present on the left-hand strap.

While all the straps had the same homologation number it was clear that one of the shoulder straps had been taken from another set – a reminder that it is not permitted to mix and match straps from other harnesses. The driver tried to convince the scrutineers that this is how the manufacturer returned the belts to them, however on closer inspection only the serial numbers on the lap belts matched which point the finger again at mixing straps on the harness set.
